Flood Management and Remedial Measures for Dikmen, Northern Cyprus

Noor Ahmad Yaqubi

Middle East Technical University NCC

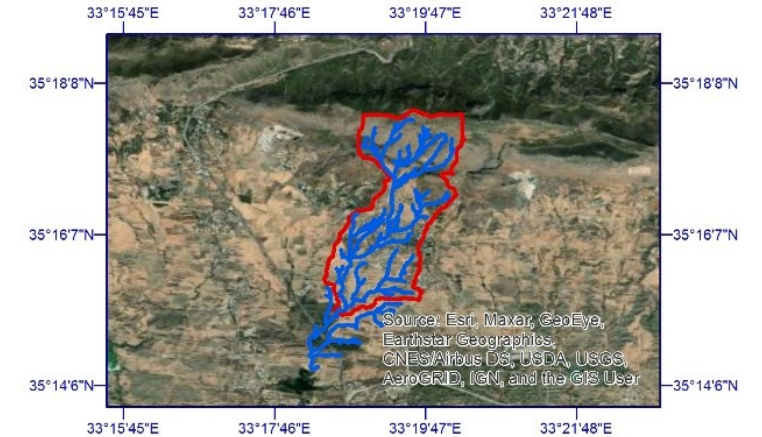
Basin Area is 8 km²

- Sub-Basin Areas

- Top Sub-Basin 2.0 km²
- Mid Sub-Basin 0.9 km²
- Low Sub-Basin 0.6 km²

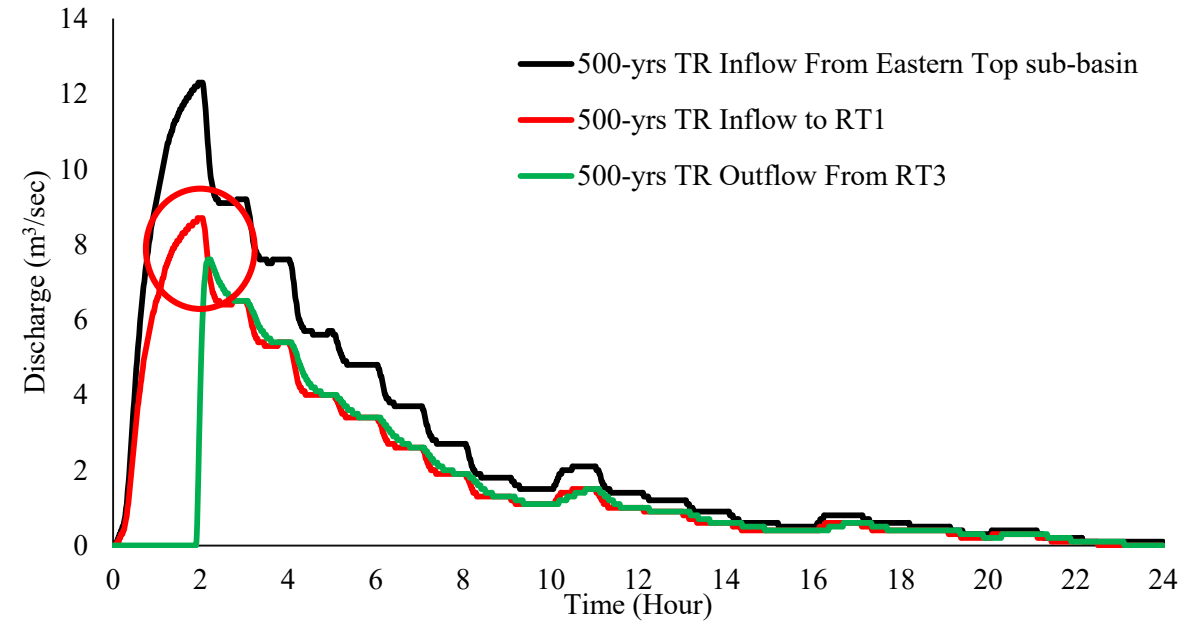
Reservoir W/O Bottom Outlet effects on 500-years Return Period Flood Hydrographs of Top sub-basin

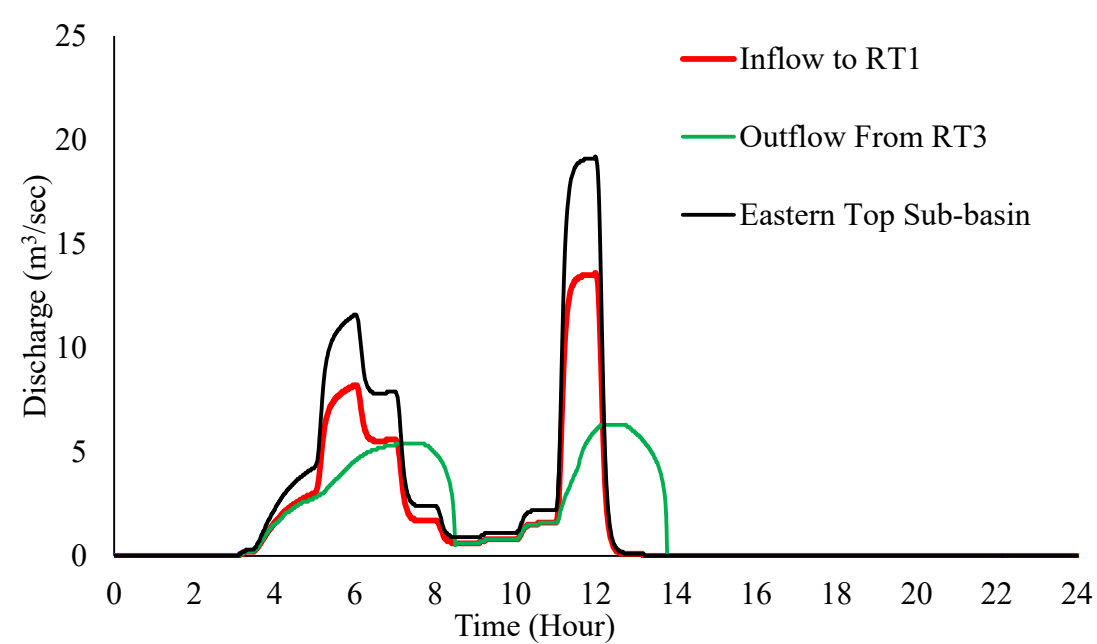
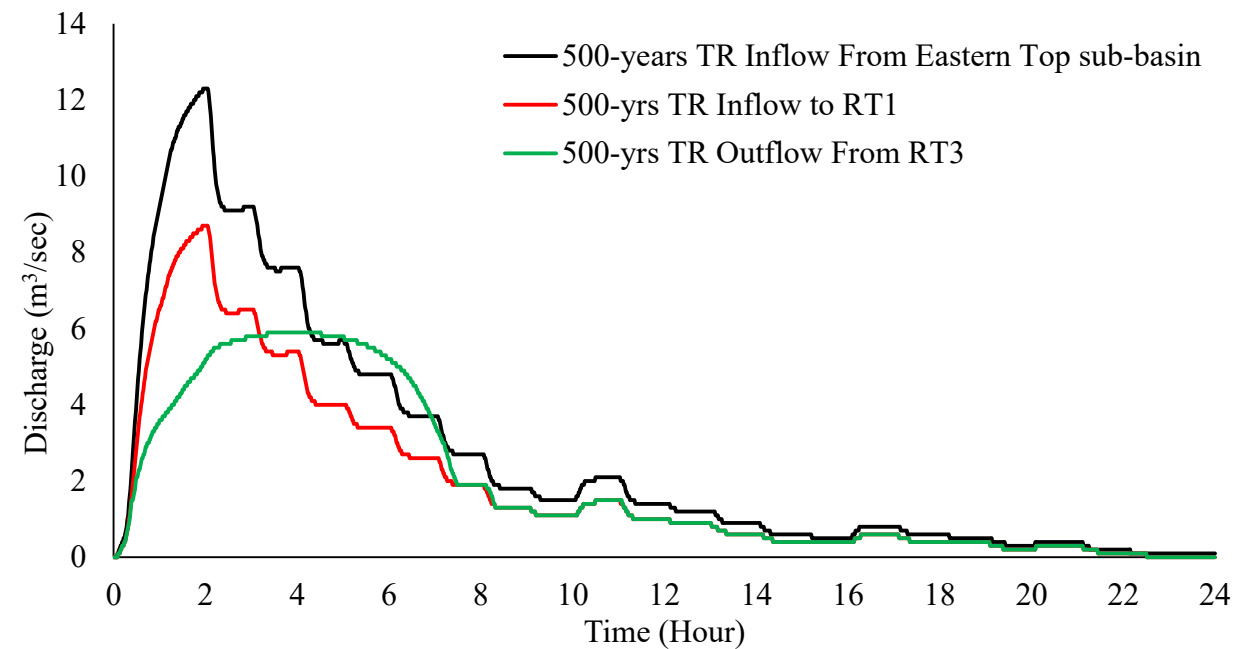
2018- Flood Routed Hydrographs after Reservoirs with 1.0 m Bottom Outlets in Top sub-basin Effect of Reservoirs with 1.0 Diameter Bottom Outlets on 500-years Flood Hydrograph of Mid sub-basin

Summary of the Flood Routing Analysis of Reservoirs 1.0 m Bottom Outlets
