Flood Risk Analysis Iskele Long-Beach Area

Assist. Prof. Dr. Bertuğ Akıntuğ

Civil Engineering Program Middle East Technical University – Northern Cyprus Campus

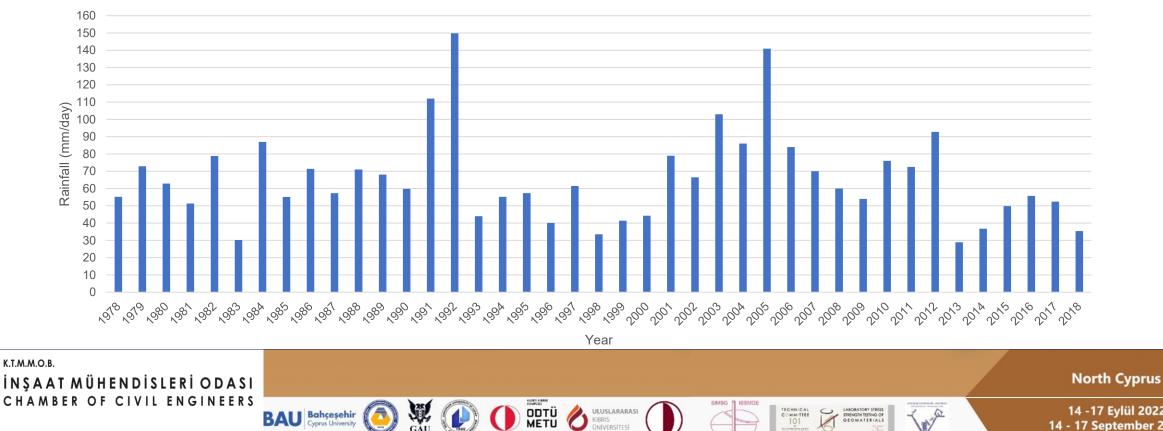
Rainfall Analysis

Meteorological Station: Kantara (1978-2018) lacksquare

Observed max. daily rainfall in a year. •

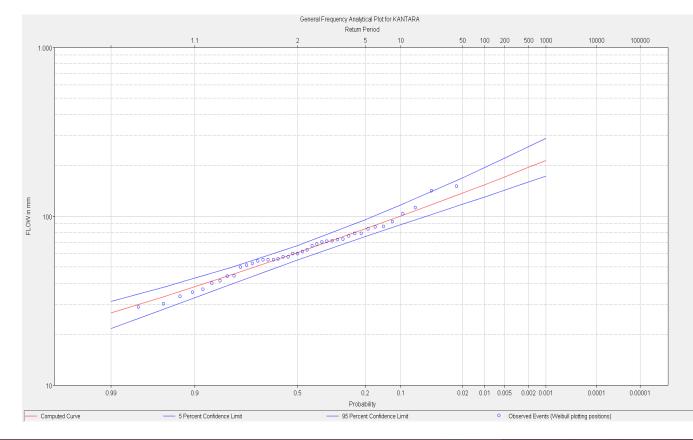
RAINFALL FREQUENCY ANALYSIS

Kantara Station

• Log-Pearson Tip III

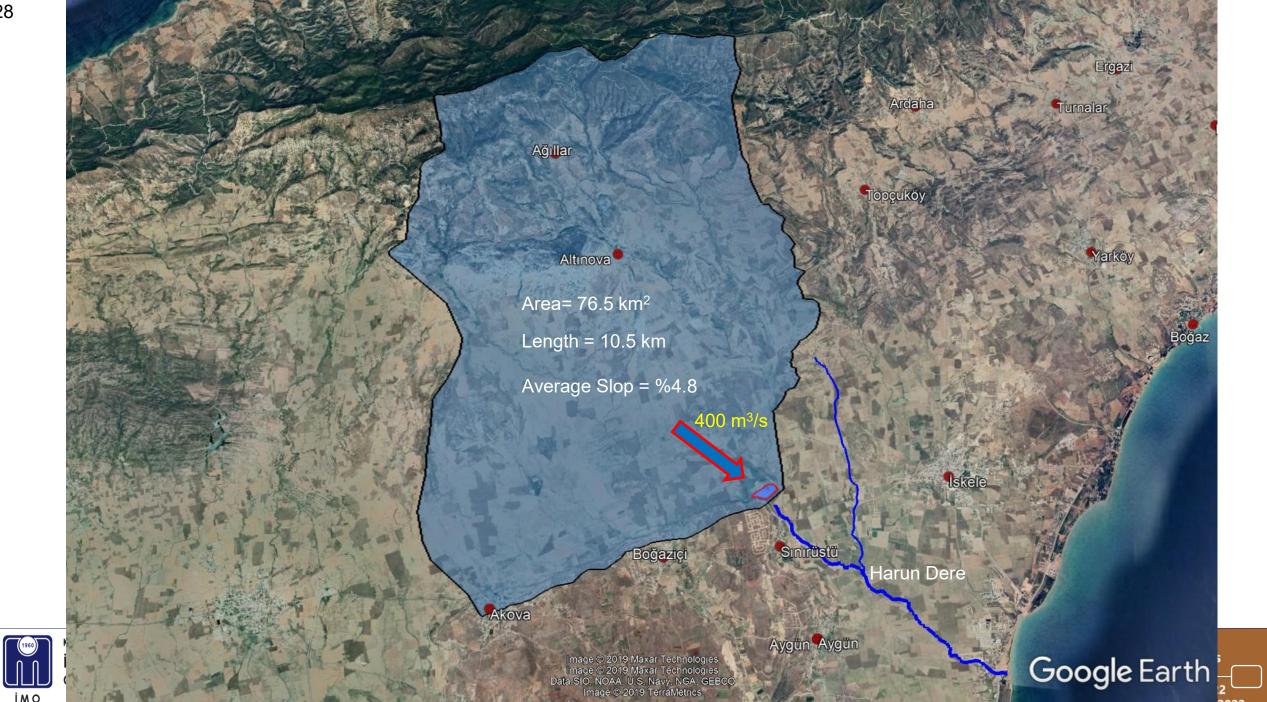
Hydrologic Modelling (Rainfall-Runoff)

• Kantara meteorological station

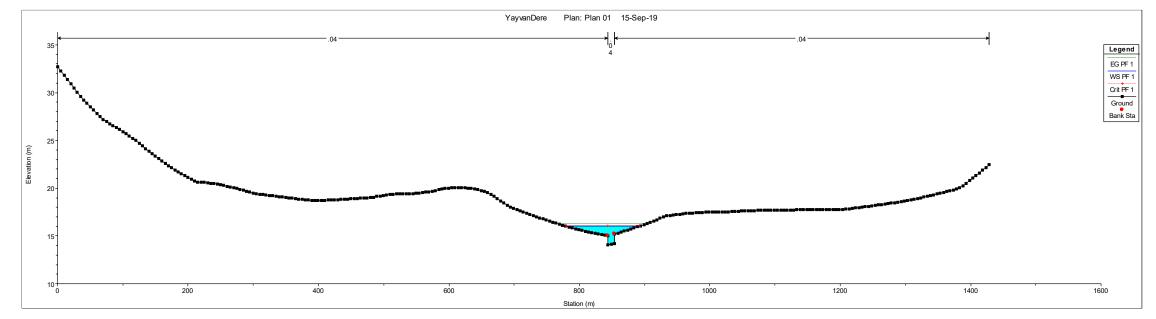
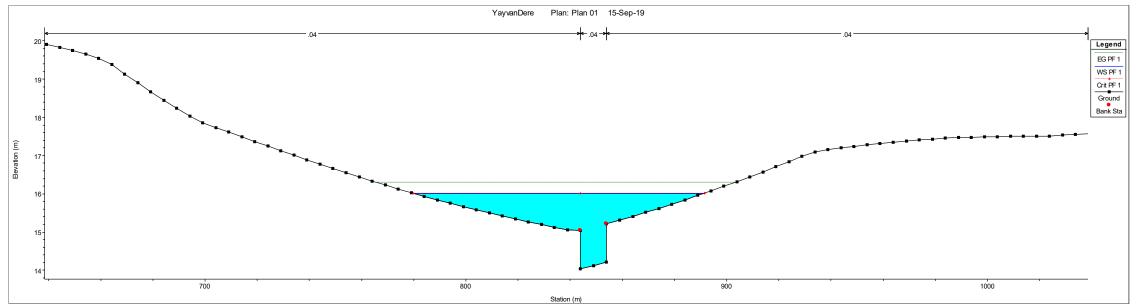
Hydraulic Modeling HEC-RAS
