A NOVEL APPLICATION OF CLOSE RANGE PHOTOGRAMMETRY FOR EARTH RETAINING WALL AND SLOPE STABILITY ASSESSMENT

Mehrdad Nategh, Abdullah Ekinci, Anoosheh Iravanian

Near East University

2nd National Civil Engineering Symposium
2. Ulusal İnşaat Mühendisliği Sempozyumu
14-15 Eylül 2022
14-15 September 2022

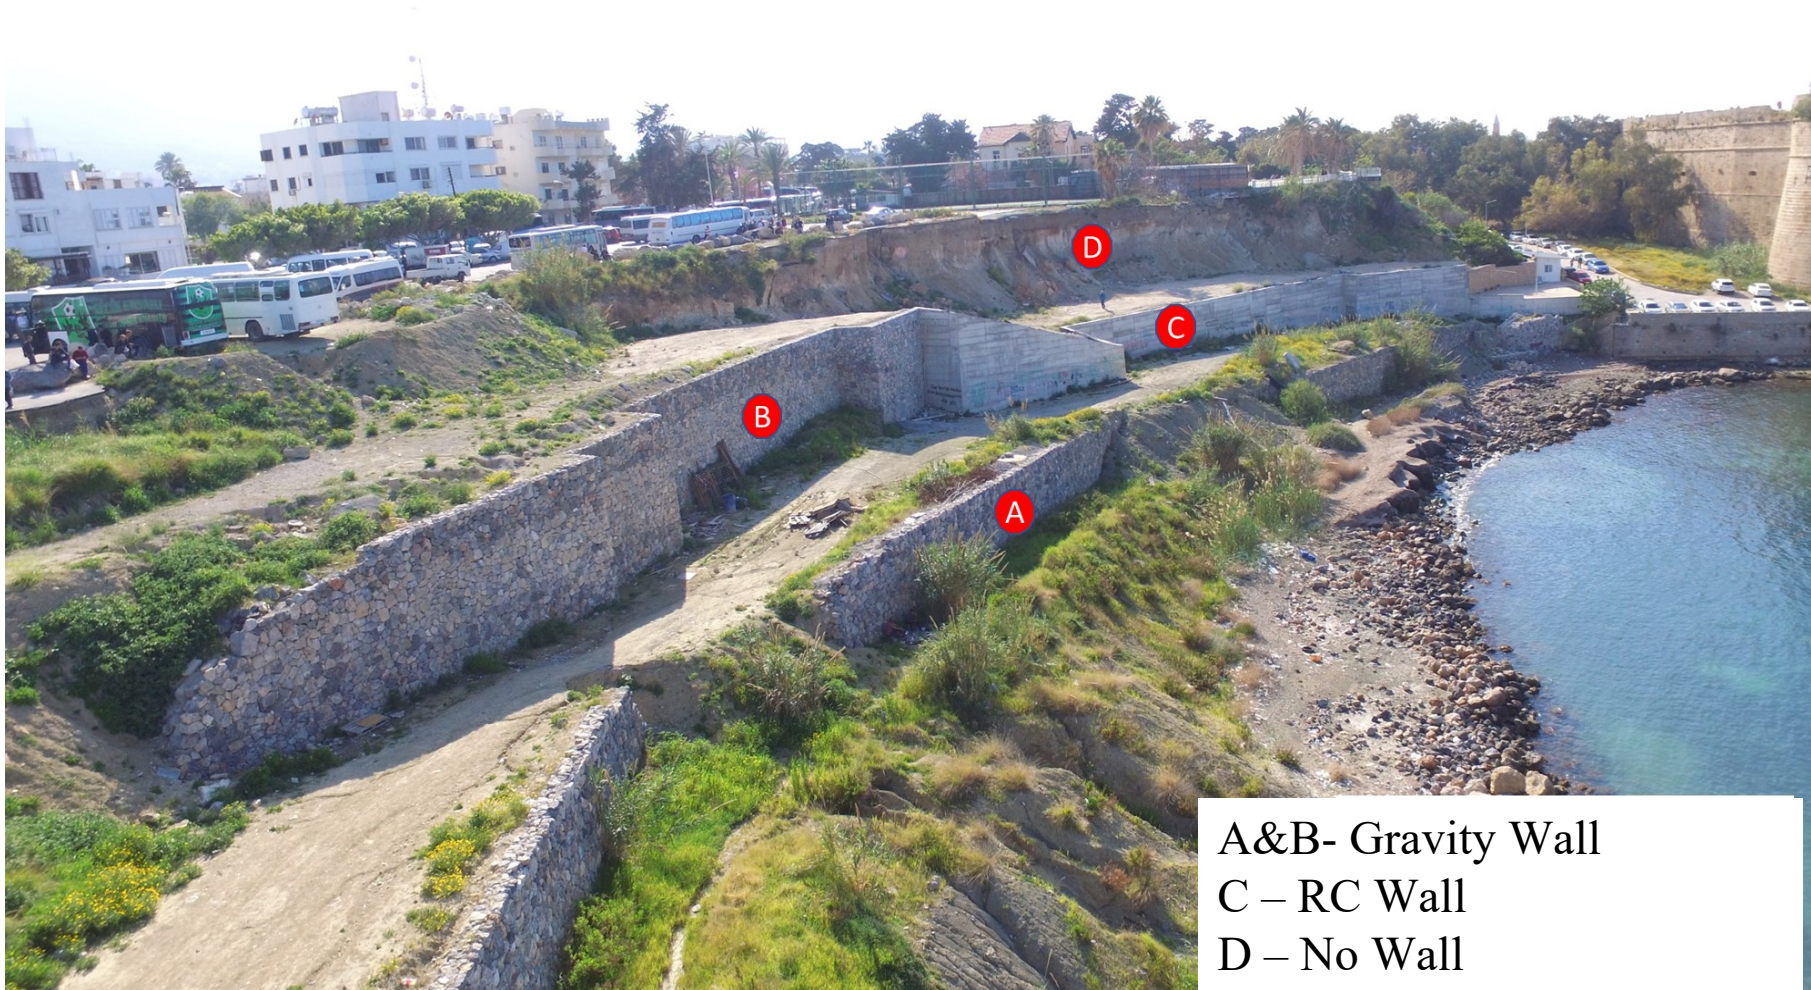
Study Area

A&B- Gravity Wall
C – RC Wall
D – No Wall

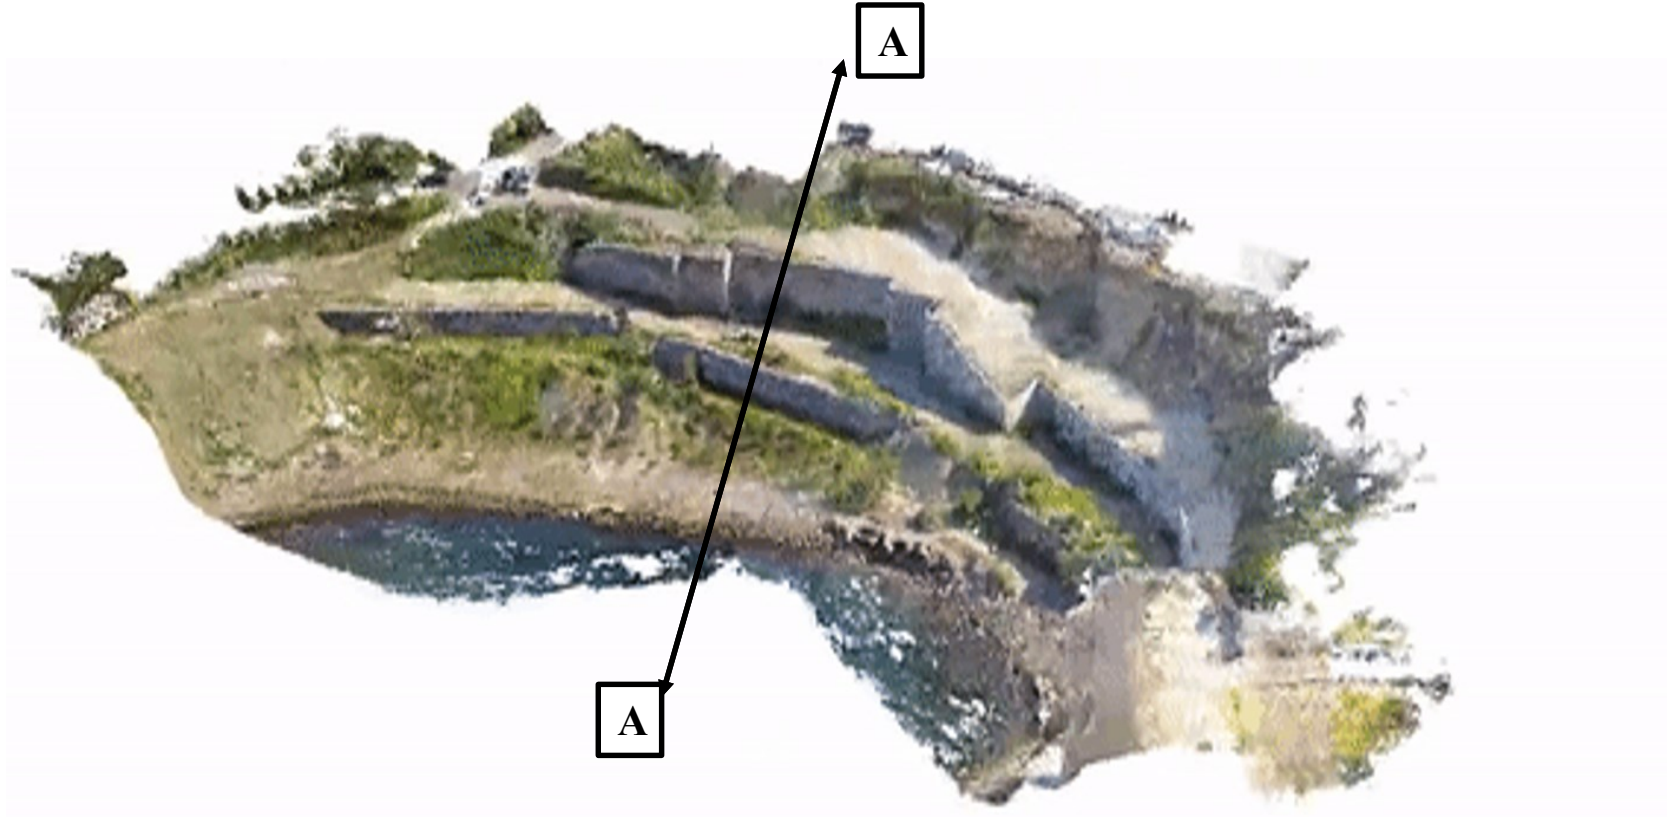
Close-Range Photogrammetry

**120 photos were
taken at every epoch**

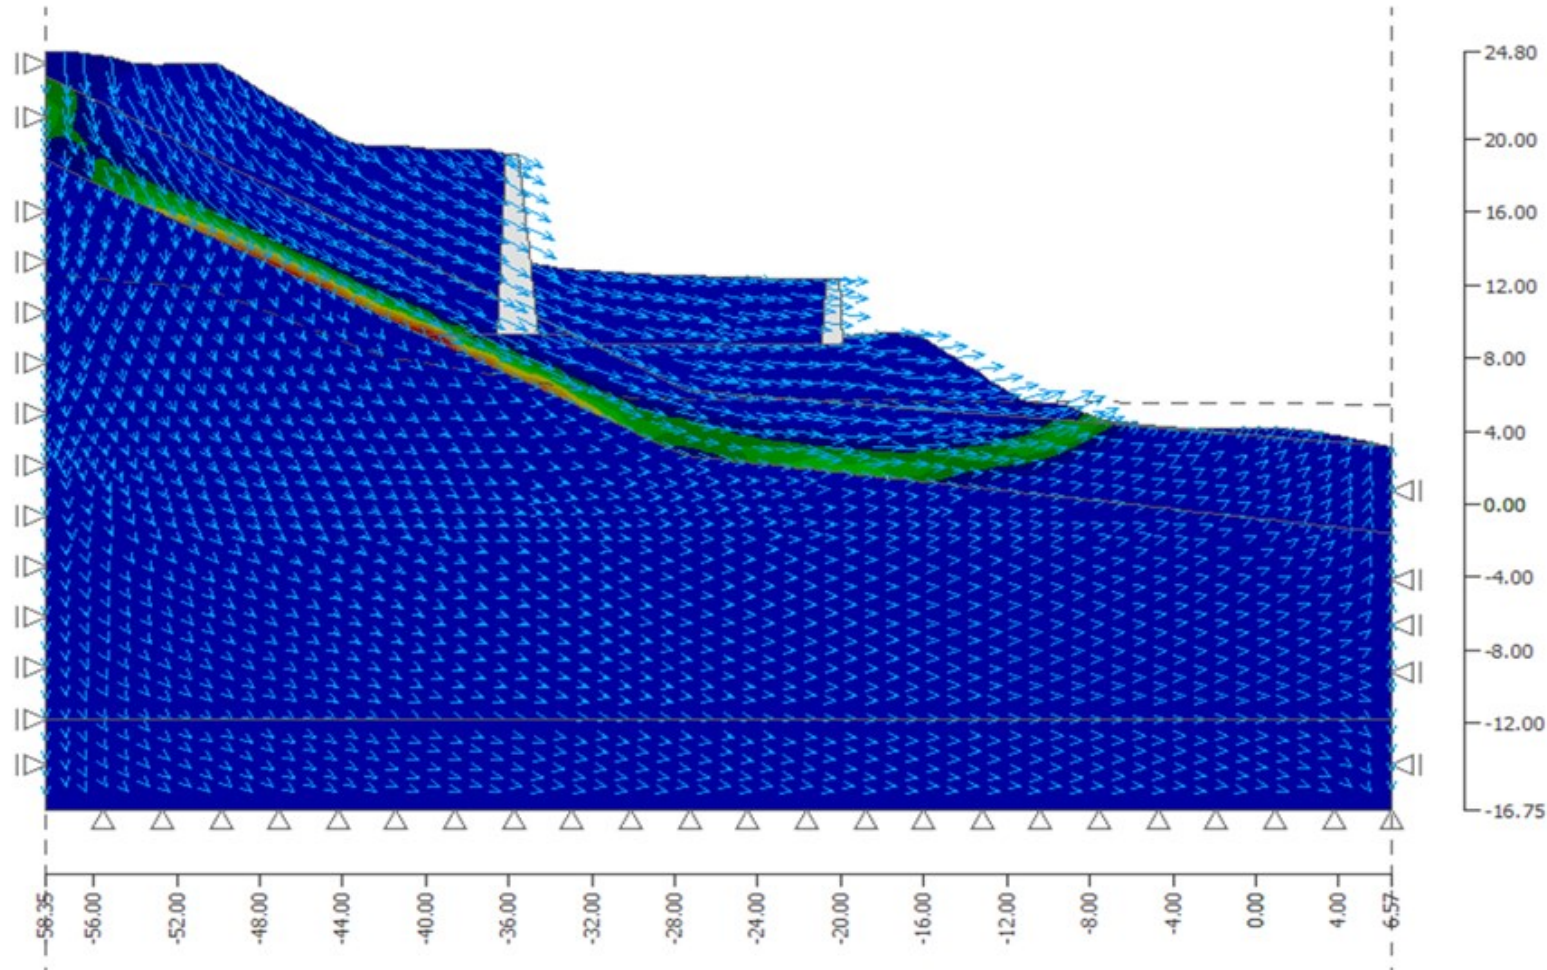
Numerical study (FEM)

- Plaxis 2D
- Geo5

- The close-range photogrammetry method which was adopted for monitoring the slope, provides valuable results and these outcomes endorse with high accuracy by the numerical analyses studies conducted with the geo5 and Plaxis 2D.

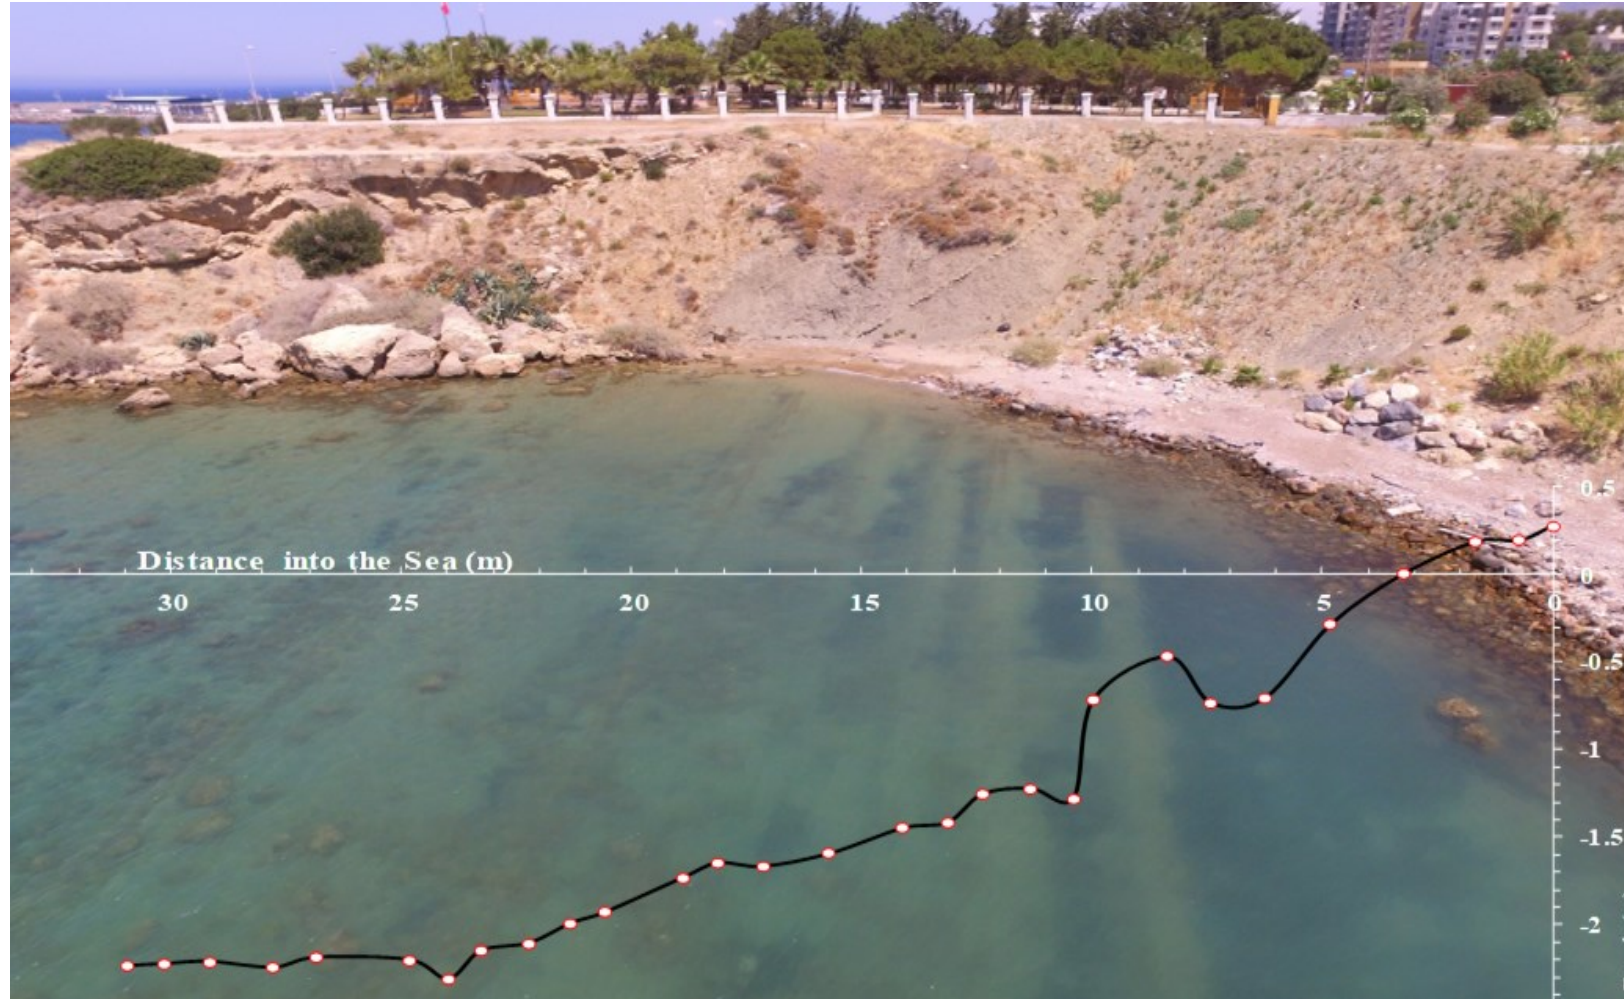
Toe of the Slope in the Sea – Cross Section A-A

- As it is obvious from the numerical analyses, the toe of the slide is placed in the sea and this phenomenon has been proved again by the bathymetric survey in the sea with the GNSS. This important fact expresses that the retaining walls are not a proper protection even with an appropriate design.

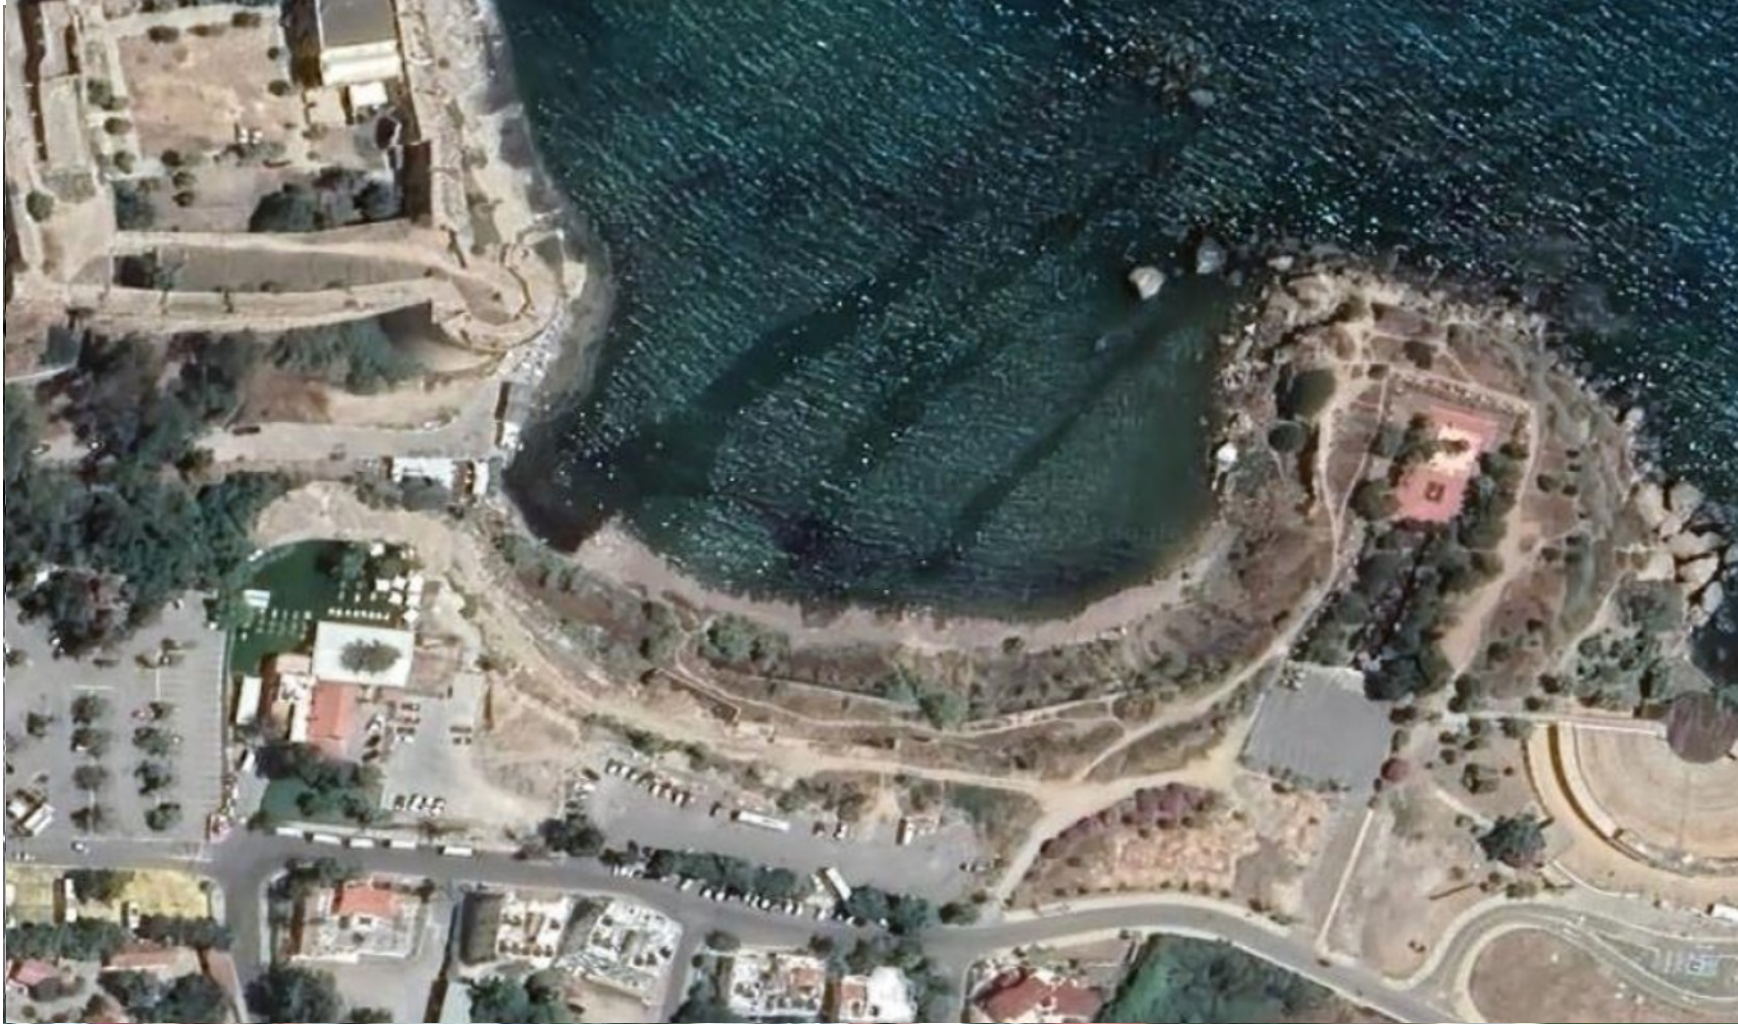
The satellite photos of the study area in different years

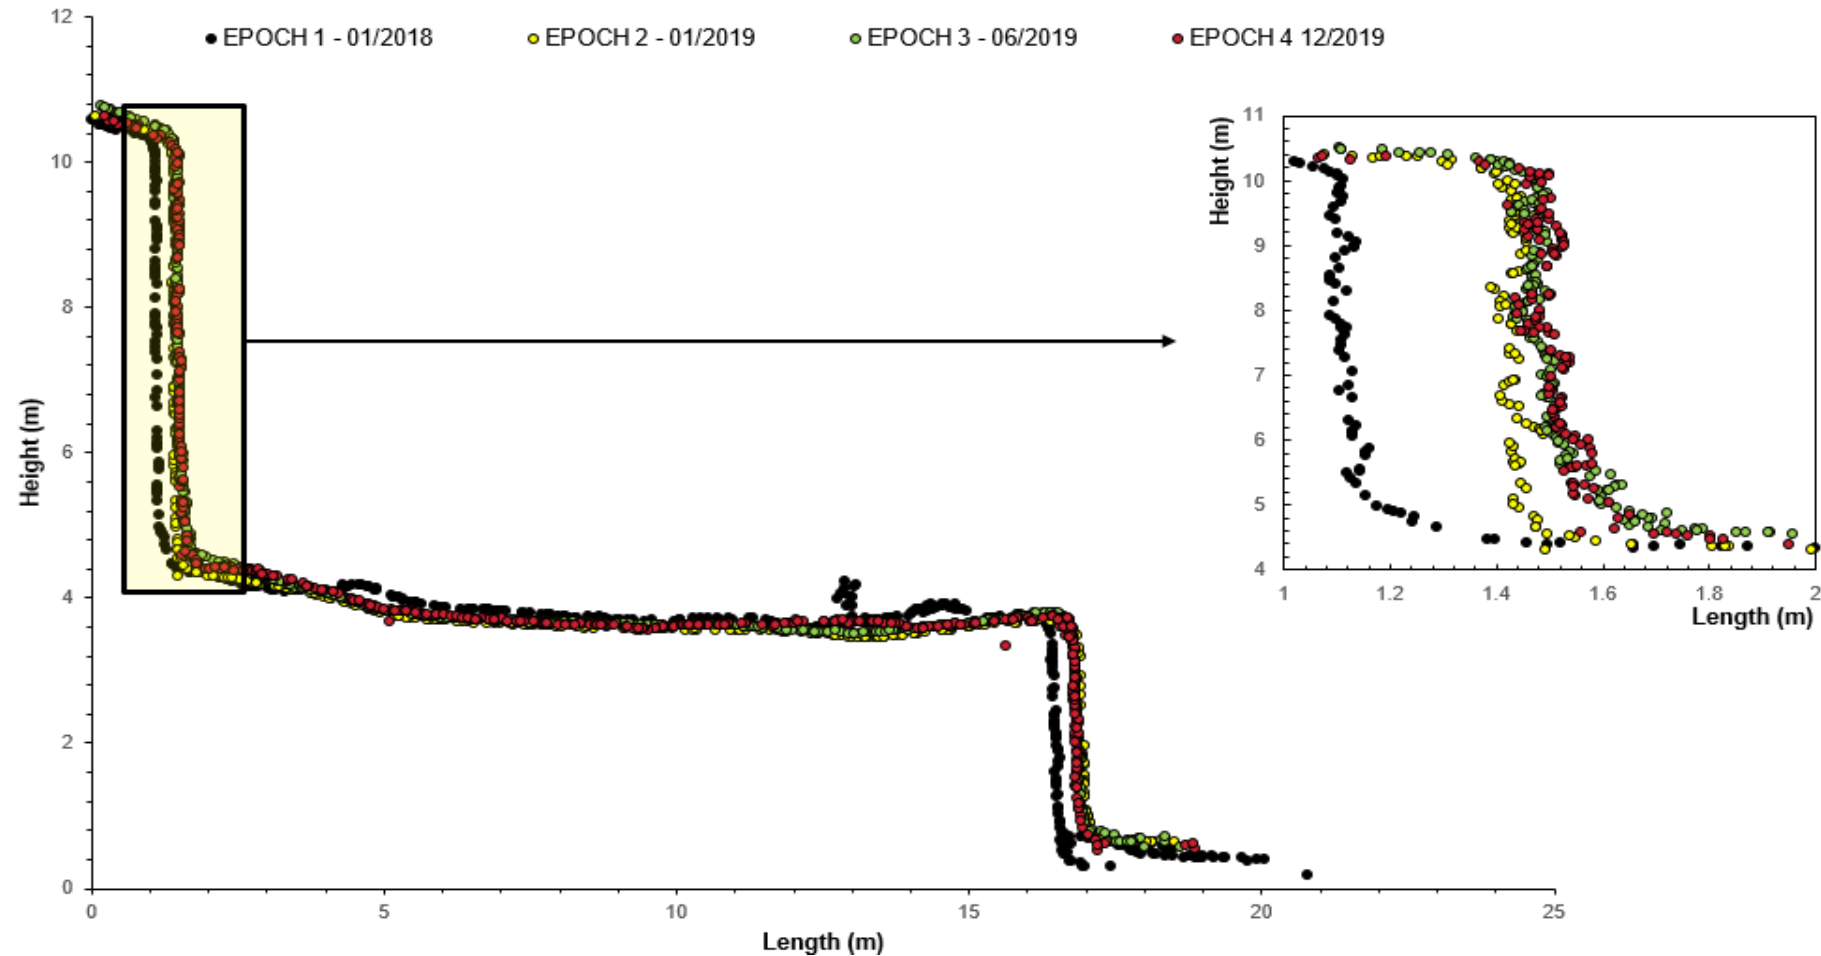
Data Processing – Plot of Strip – Cross Section A-A

- The comparison between the epochs in a 2 years' period (from Jan 2018 to Dec 2019) revealed that the slide movement at the first year was about total movement in two years. It can be found that after 8 years of sliding, the sharp movement still can occur.
